# FUGRO DISASTER MANAGEMENT

**Fugro's disaster support services contributed to a fast recovery from the effects of tropical cyclone Marcia which left more than 67,700 households without power when it made landfall in February in Queensland, Australia.**

## **ROAMES DISASTER RESPONSE SERVICE**

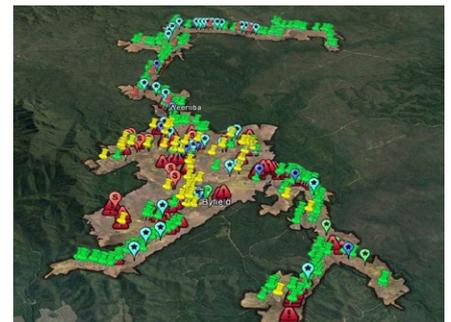
*Fugro's disaster report services was used by Ergon Energy to quickly assess damage.*

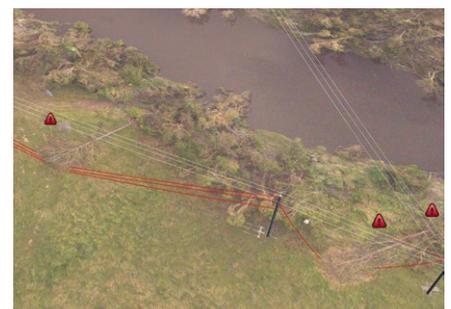
*Roames network model showing post-storm damage.*

Roames rapid network assessment identified and modeled more than 654 instances of critical damage to infrastructure within Ergon's network. The report modeled downed poles and wires and damaged buildings and roads, as well as other debris related issues.

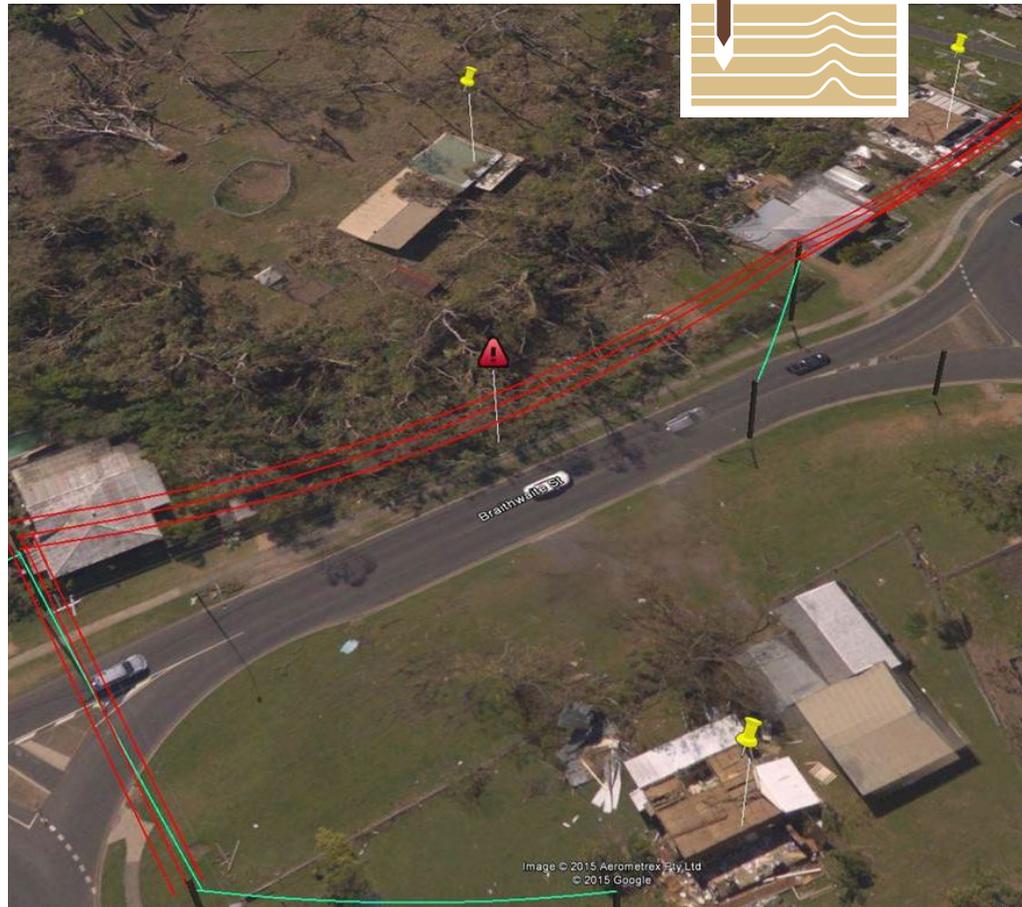
Rapid assessment to identify damaged infrastructure, downed poles and wires to assist with response and recovery effort.

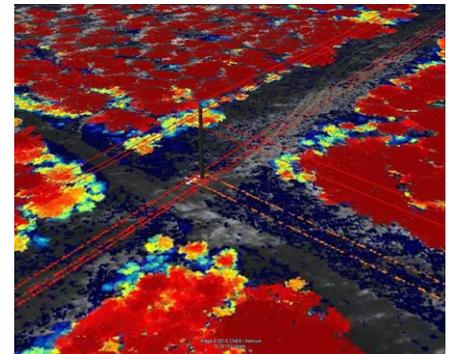
Ergon 3D network model with vegetation height map in Roames virtual world before Marcia.

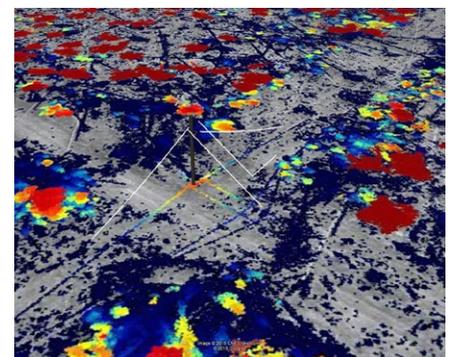
New model visualises network after Marcia with down power lines and annotated damage flags.
