The search for HMAS AE1

Solving a 103-year-old mystery

How the latest hydrographic surveying techniques discovered the first Allied submarine to be lost in WW1

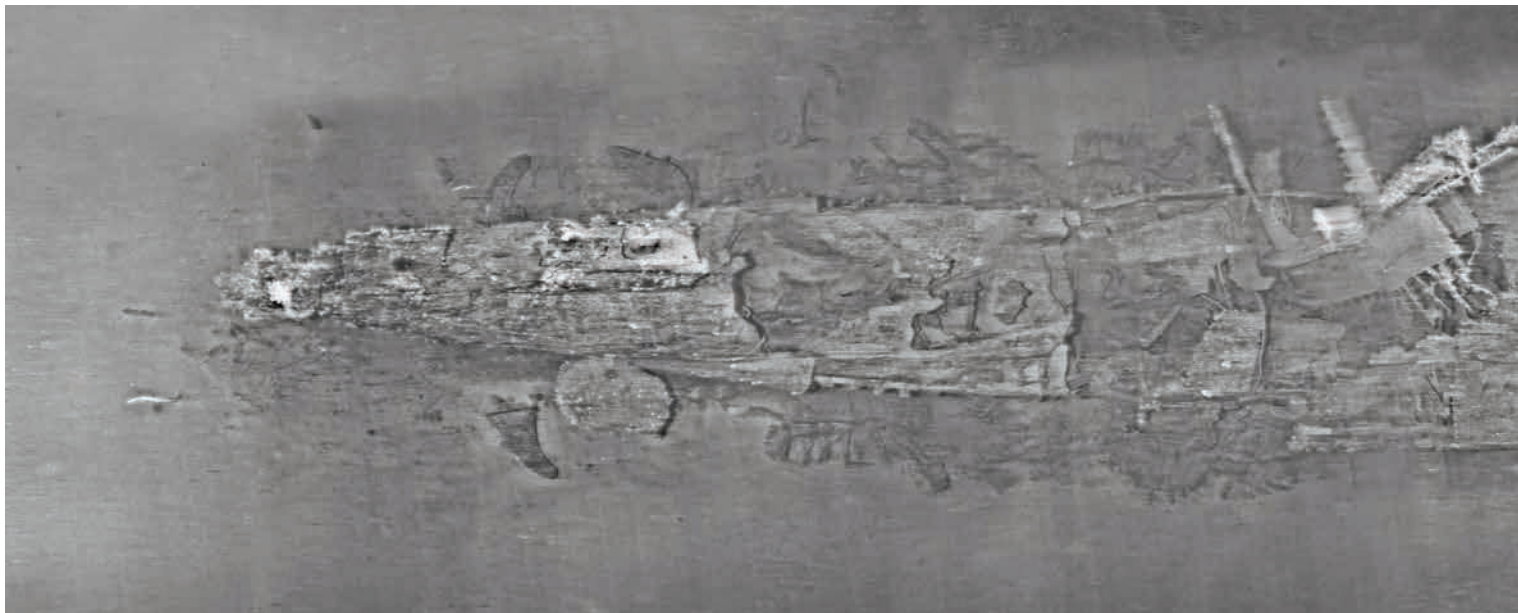
A photo-mosaic of the *AE1*, from data captured from the sea surface during the successful search in December 2017.

The SeaBug drop camera was an extremely useful tool. It sits at the end of a long cable and is literally dropped into place. Like the AUV it is 3,000m rated; and it provides real time video, 14.7 mega pixel digital stills; has a 5x optic zoom and dual lasers mounted to provide image scaling. That's what captured many of the close-up pictures from the dynamically positioned vessel when in station-keeping mode. There are two different types of image – the one of the entire submarine itself (which is a photo mosaic captured from the sea surface) and others taken as single shots close to the seafloor.

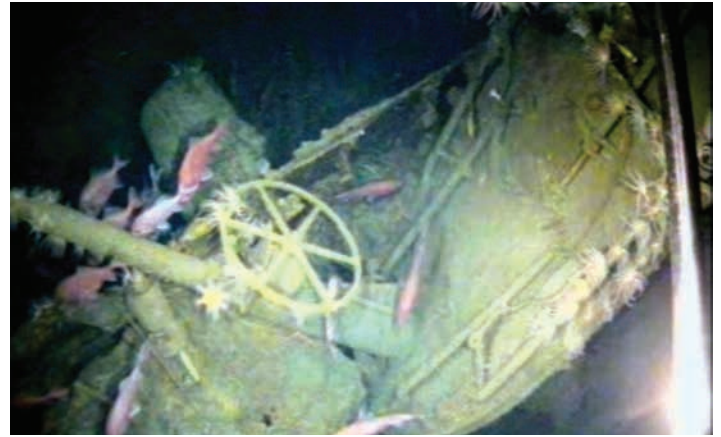
Photograph showing the helm of AE1 in its final resting place.
