FUGRO-SUHAIMI

PETROGRAPHIC EXAMINATION

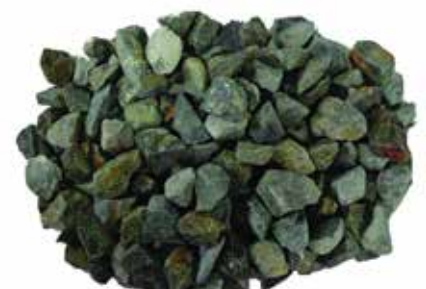
Portion of a coarse aggregate sample that has been petrographically examined.

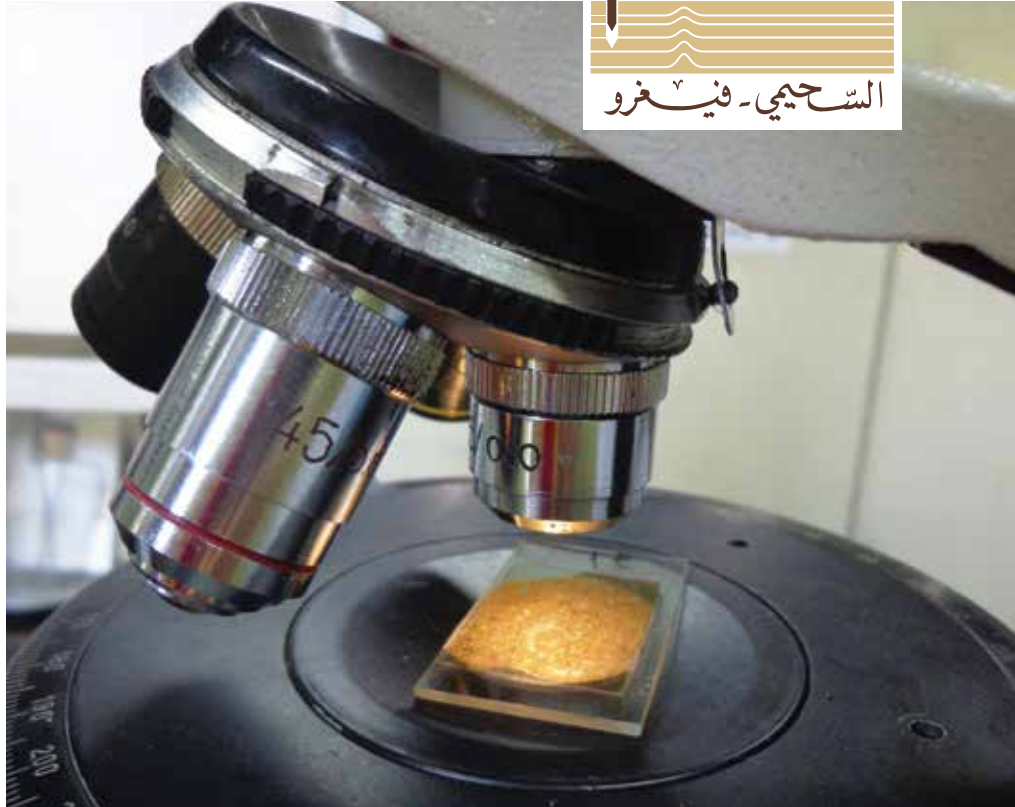
Analysis of the volumetric proportions of individual concrete constituents.

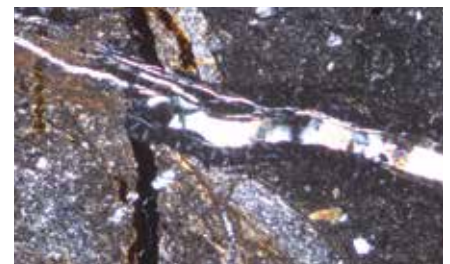
Concrete suffering from cracking induced by ASR.
