FUGRO-SUHAIMI

PETROGRAPHIC EXAMINATION

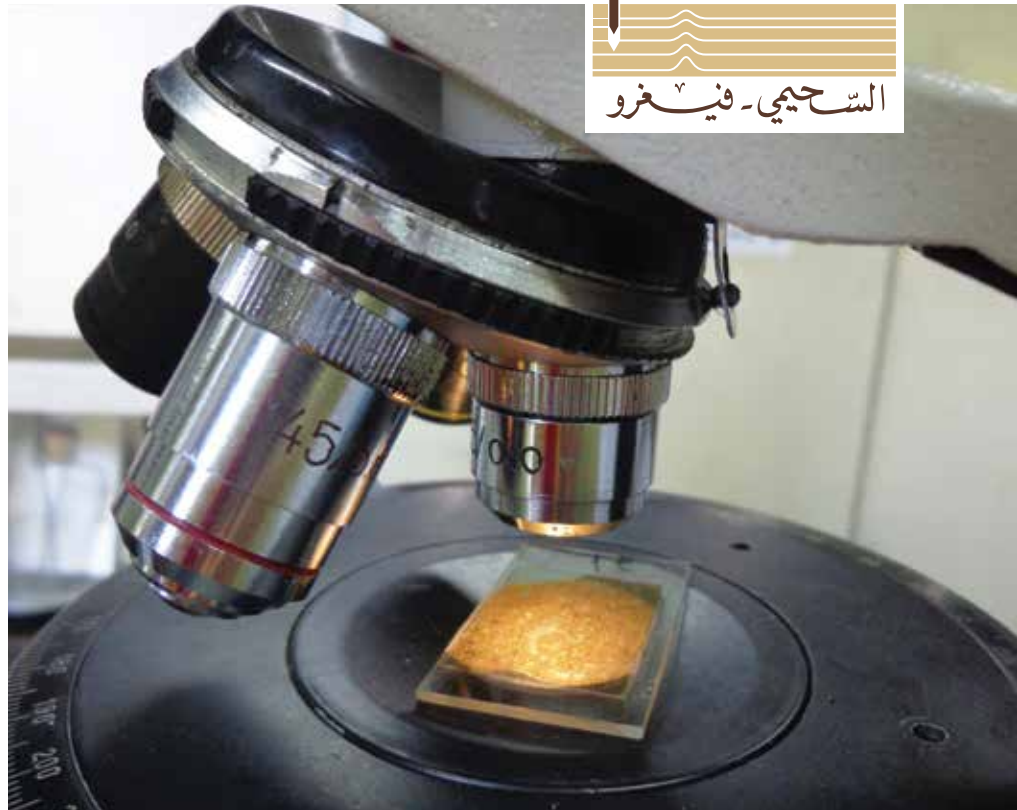
Analysis of the volumetric proportions of individual concrete constituents.

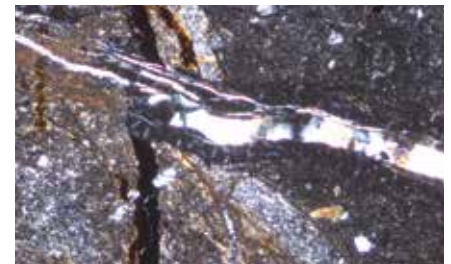
Concrete suffering from cracking induced by ASR.
