FUGRO-SUHAIMI

FIRE-DAMAGED CONCRETE: ASSESSMENT AND REPAIR

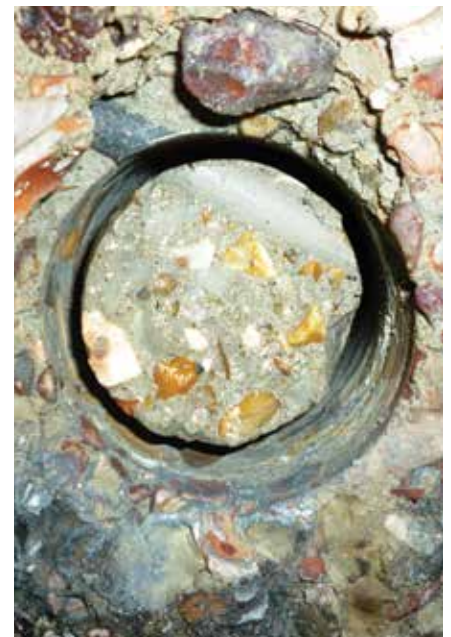
Core sample extracted for laboratory testing.

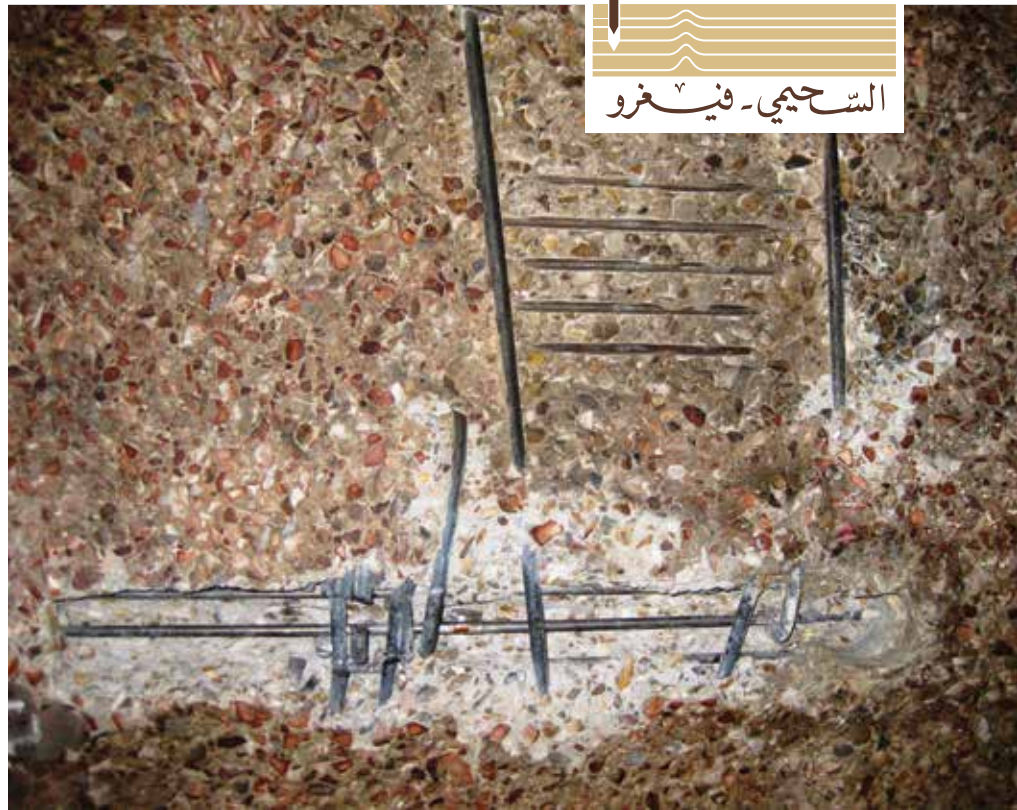
Spalled surface affected by heating exposing pre-stressed tendons.

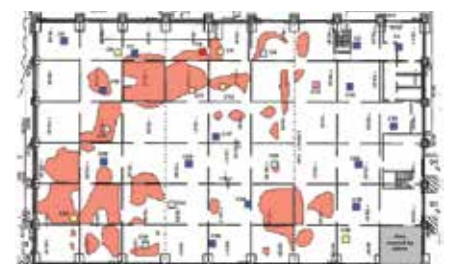
Visual assessment of the extent of fire damage of a commercial property.
